DEPARTMENT OF TRANSPORTATION

Quality Assurance and Source Inspection

Contract #: 04-0120F4Cty: SF/ALA Rte: 80 PM: 13.2/13.9File #: 69.28**WELDING INSPECTION REPORT****Resident Engineer:**Siegenthaler, Peter**Address:** 333 Burma Road**City:** Oakland, CA 94607**Report No:** WIR-023771**Date Inspected:** 12-May-2011**Project Name:** SAS Superstructure**OSM Arrival Time:** 700**Prime Contractor:** American Bridge/Fluor Enterprises, a JV**OSM Departure Time:** 1900**Contractor:** Zhenhua Port Machinery Company, Ltd (ZPMC), Changxing Island **Location:** Shanghai, China**CWI Name:** Li yan hua**CWI Present:** Yes No**Inspected CWI report:** Yes No N/A**Rod Oven in Use:** Yes No N/A**Electrode to specification:** Yes No N/A**Weld Procedures Followed:** Yes No N/A**Qualified Welders:** Yes No N/A**Verified Joint Fit-up:** Yes No N/A**Approved Drawings:** Yes No N/A**Approved WPS:** Yes No N/A**Delayed / Cancelled:** Yes No N/A**Bridge No:** 34-0006**Component:** OBG Components**Summary of Items Observed:**

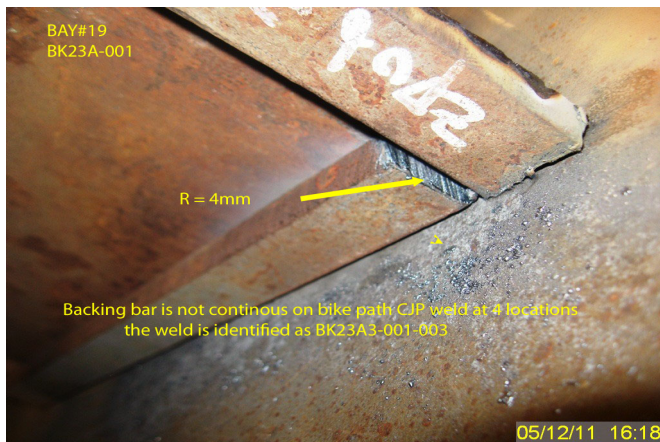
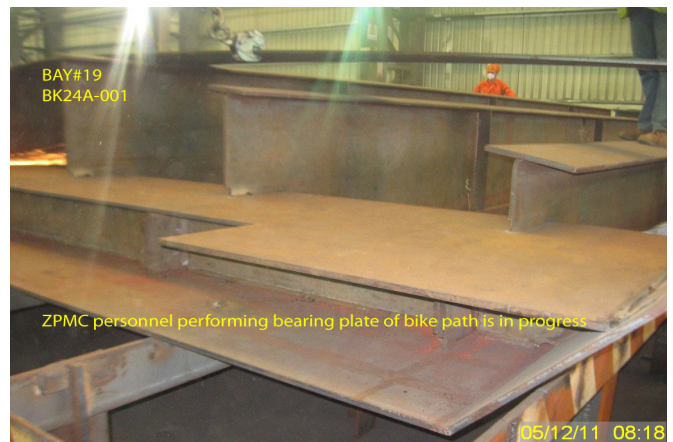
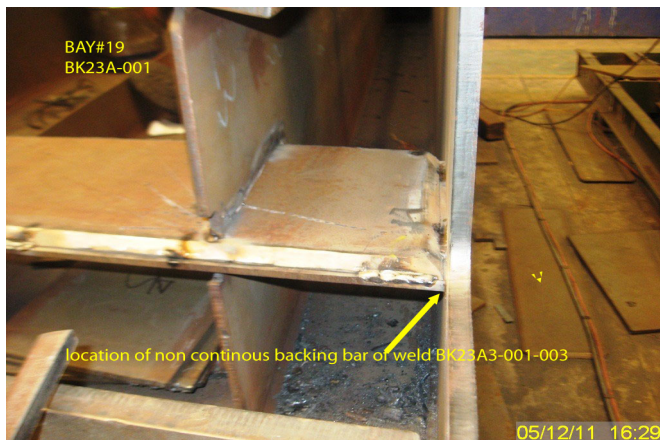
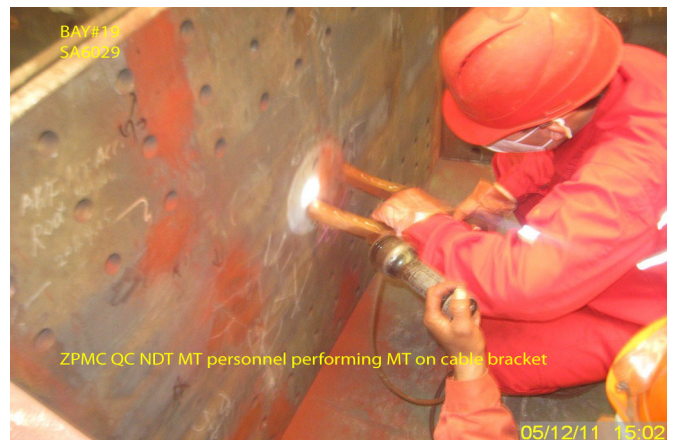
During in process visual inspection it is found that backing bar is not continuous in between the bearing plate CJP weld is identified as BK23A3-001-003,006 and BK3A5-001-002,009 more than that 4mm. this is marked near by the weld and informed to ZPMC QC Mr. Li ping and ABF QA Mr. Peng wen june for further repair work to go before welding. See the attached photos.
